**Review of Sea-grass Wrack
Management Trial
Port Geographe – October 2018**

**RD Gee BSc (Hons), PhD and
RC McDavitt Assoc WAIT, FIE Aust, MIET**

**A report to the Busselton City Council, Department
of Transport and residents of Port Geographe by the
Port Geographe Landowners Association Inc**

3 December 2018

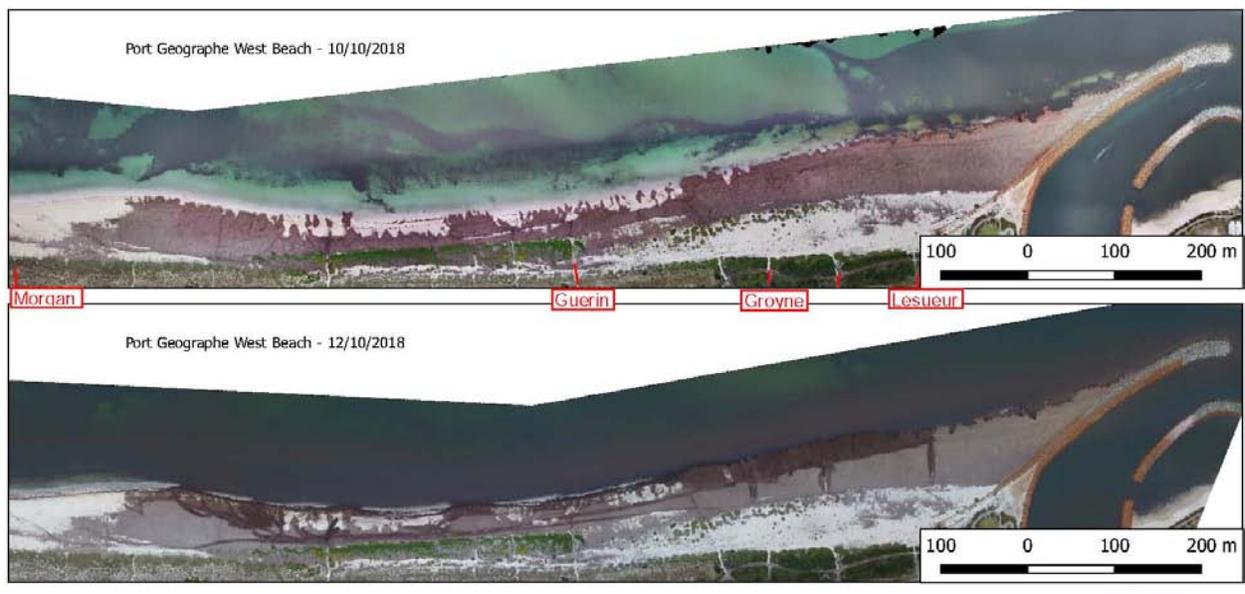
Before-and-after drone images are shown in **Figure 1**. The total area of wrack on the Western Beach, as of 10 October 2018 has been measured by us as 59,840m². Thicknesses ranged between 0.25m to 1.0m with some localised heights immediately adjacent to the western groyne exceeding 2 metres. Taking an average thickness of 0.75m, gives a volume of 44,880 m³, which is less than the 60,000m³ trigger volume.

The mechanical intervention program of October 2018 involved cutting bulldozer slots through the wrack, and levelling the compacted seaward face of the wrack. Altogether there were seven bulldozer slots through the wrack perpendicular to the beach, between Morgan Street in the west and Lesueur Close in the east – a distance of 900m. It is notable that all slots correspond to

Figure 1: Drone images of Western Beach before (upper 10/10/2018) and after (lower 12/10/2018) mechanical intervention: Tracks from street terminations shown in red. Wrack is medium grey. Bulldozed slots and flattened scarp appear as dark grey in lower image

By a combination of compaction and etching by waves, the seaward edge of the wrack had developed a steep face varying from 0.4m to 1.7m in height over most of its length. This face was mechanically flattened by raised-blade traverses over 900 metres of wrack in a swath 20m wide.

To date, the leveling of the seaward scarp of the wrack has not resulted in any natural removal of wrack from the beach. However it has exposed the surf zone of the beach profile which re-activates littoral sand movement. This is not the desired action at present. Fortunately the remnant scarps close to the WGN continue to cover sand that would otherwise be the active surf zone. These undisturbed scarps are assisting the natural build-up of sand.

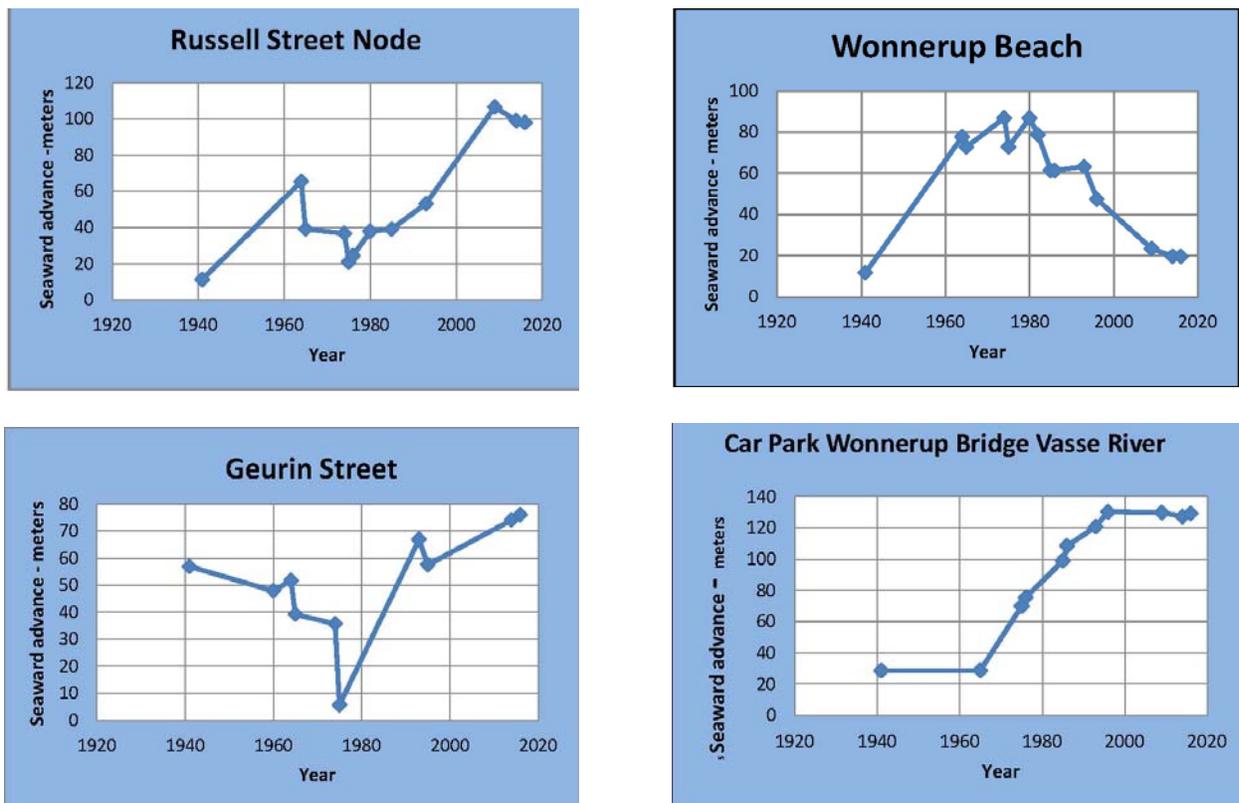
Figure 2: 80-year accretionary curves.

The dip sharp dip in Russell St and Guerin St growth curves is attributed to Cyclone Alby in 1978. The pronounced downturn in the growth curve for Wonnerup Beach (measured 60m east of the revetment of Port Geographe is attributed to starvation of sand that is not naturally by-passing at the present time. This gives some justification for localized beach-nourishing programs at Wonnerup Beach. It is noted that even in its depleted state **the beach has nevertheless advanced from its 1941 position.**

The part of the coastline between RSN, through Port Geographe to Wonnerup lagoons, shows some of the strongest accreting rates in the whole of Geographe Bay. For example RSN has grown 90 metres seaward (but not moved laterally) in the last 75 years, giving an accretion rate of 1.2m/y. Similarly at Wonnerup Vasse River Bridge, the coast has accreted 105m in 75 years, equating to 1.4m/y. The accretion curves are non-linear generally but progressive not cyclic, as seen in **Figure 2**.

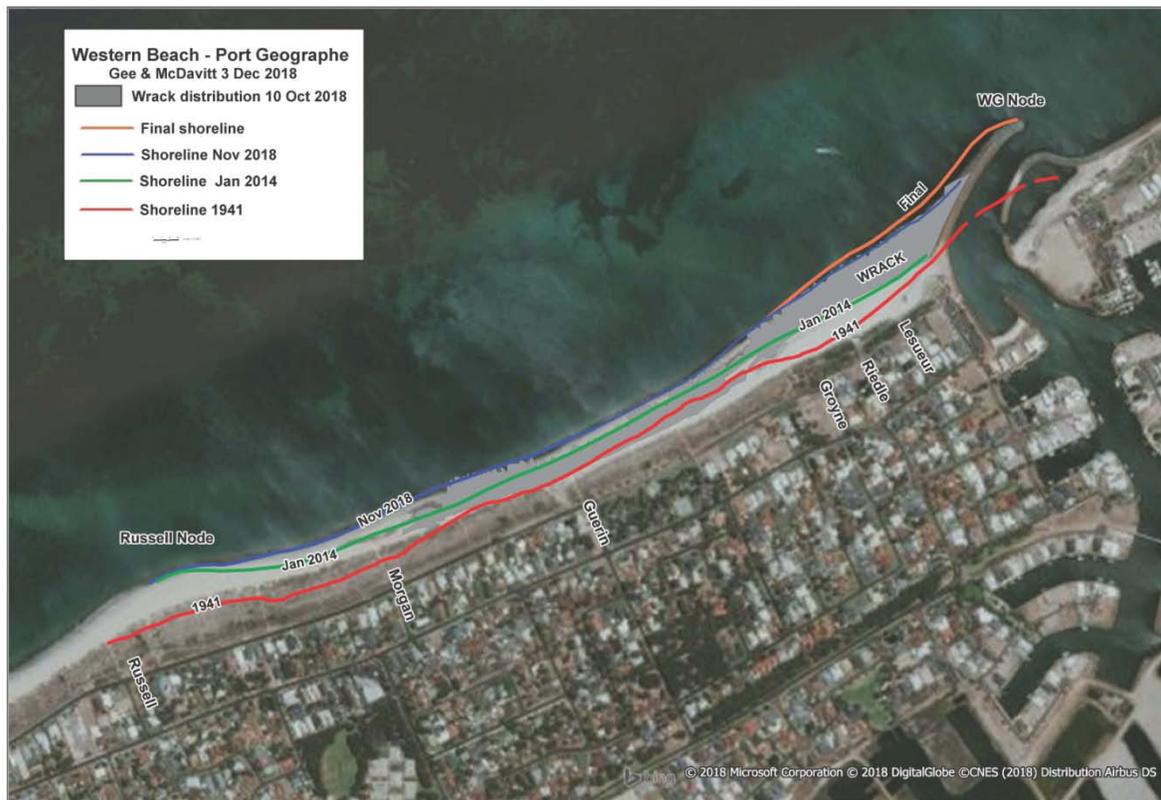
The beach-lines for Jan 2014 (green) and Nov 2018 (blue) are plotted on **Figure 3**. The 1941 beach line (red) is also plotted for reference. It is important to note the actual 1941 beach is now occupied by sand dunes, and the top of the 1941 beach, as recorded by the vegetation line on historic photos, is 45-50 meters further inland and laps against present-day Geographe Bay Road. **Table 1** shows the progression distances for different segments of Western Beach during this four-year period.

Figure 3: Western Beach between Russell Node and Western Groyne showing historic shorelines and 2018 wrack

The second mechanism involves movement of suspended sand grains in the rill channels that characterize this part of the shoreline. These occur near to shore, between the submerged beach face and near-shore sand bars. They show as dark sinuous channels on **Figure 3**, some 50 metres offshore. Currents of 0.3m/s are required to move sand grains in suspension which are easily generated in these channels by fresh-to-strong westerly and southwesterly winds.

The ideal final shore-line curve has been superimposed on **Figure 3** to represent the final curvature of the Western Beach. This final curve extends from the tip of the WGN to just beyond Groyne Road. Only a small area of 9,000m² remains to completely fill the elbow to a form smooth dynamic shape. Considering its progression into deepening water, this may require a slab of up to five metres, equating to 45,000m³ of sand. At present rates of accretion this may be achieved in one season – or more likely the beginning of the 2020 winter.

It is significant that all the historic waterlines prior to the first groyne construction for Port Geographe in 1997, show a long-lived protruding sand node that lies precisely under the present marina area. Whether by accident or design, the “final curve” presented in **Figure 3** closely mimics the 1941 and subsequent shorelines, although it is translated seaward by 90 metres due to natural accretion.
